## HAMPDEN COUNTY REGISTRY OF DEEDS

### DAMS FILE COLLECTION

### BOOK D25 – 3 (L-T)

Reports Section – Dams - Hampden County Massachusetts

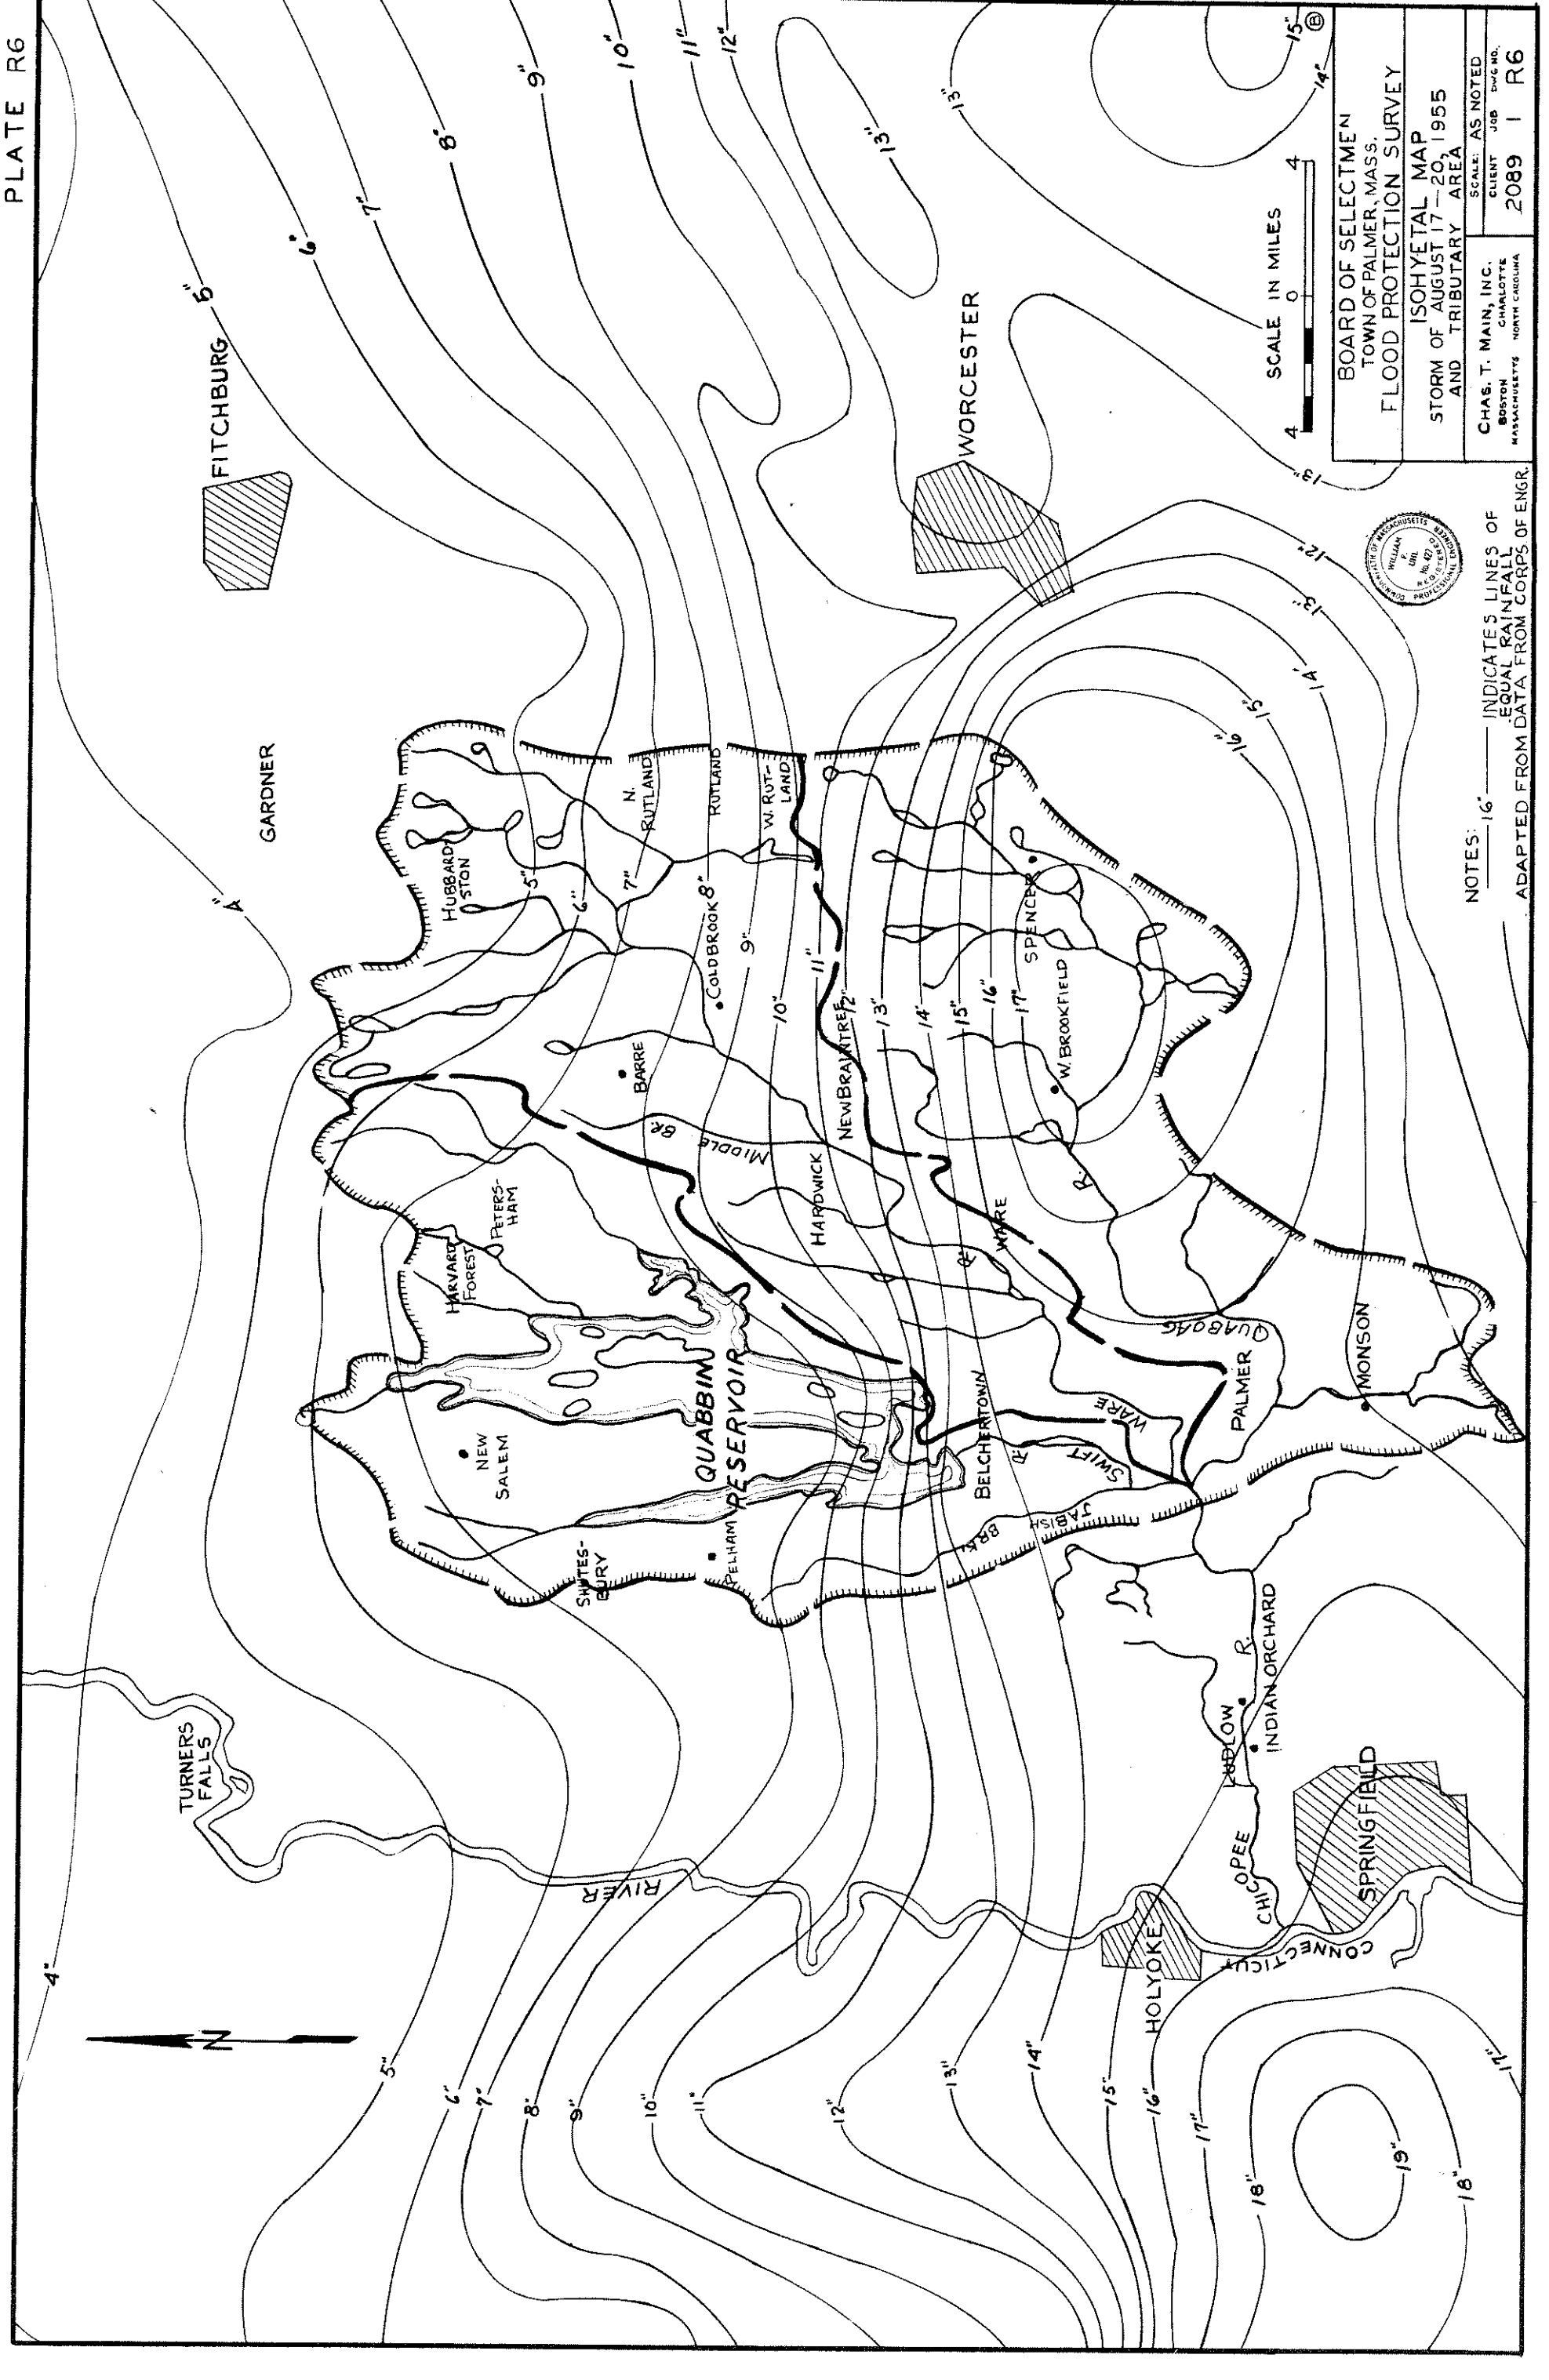
NOTES: 16" — INDICATES LINES OF  
EQUAL RAINFALL  
ADAPTED FROM DATA FROM CORPS OF ENGR.

BOARD OF SELECTMEN TOWN OF PALMER, MASS. FLOOD PROTECTION SURVEY	
ISOHYETAL MAP STORM OF AUGUST 17-20, 1955 AND TRIBUTARY AREA	
CHAS. T. MAIN, INC. BOSTON MASSACHUSETTS	CLIENT JOB NO. 2089
SCALE: AS NOTED	DWG NO. 1 R6

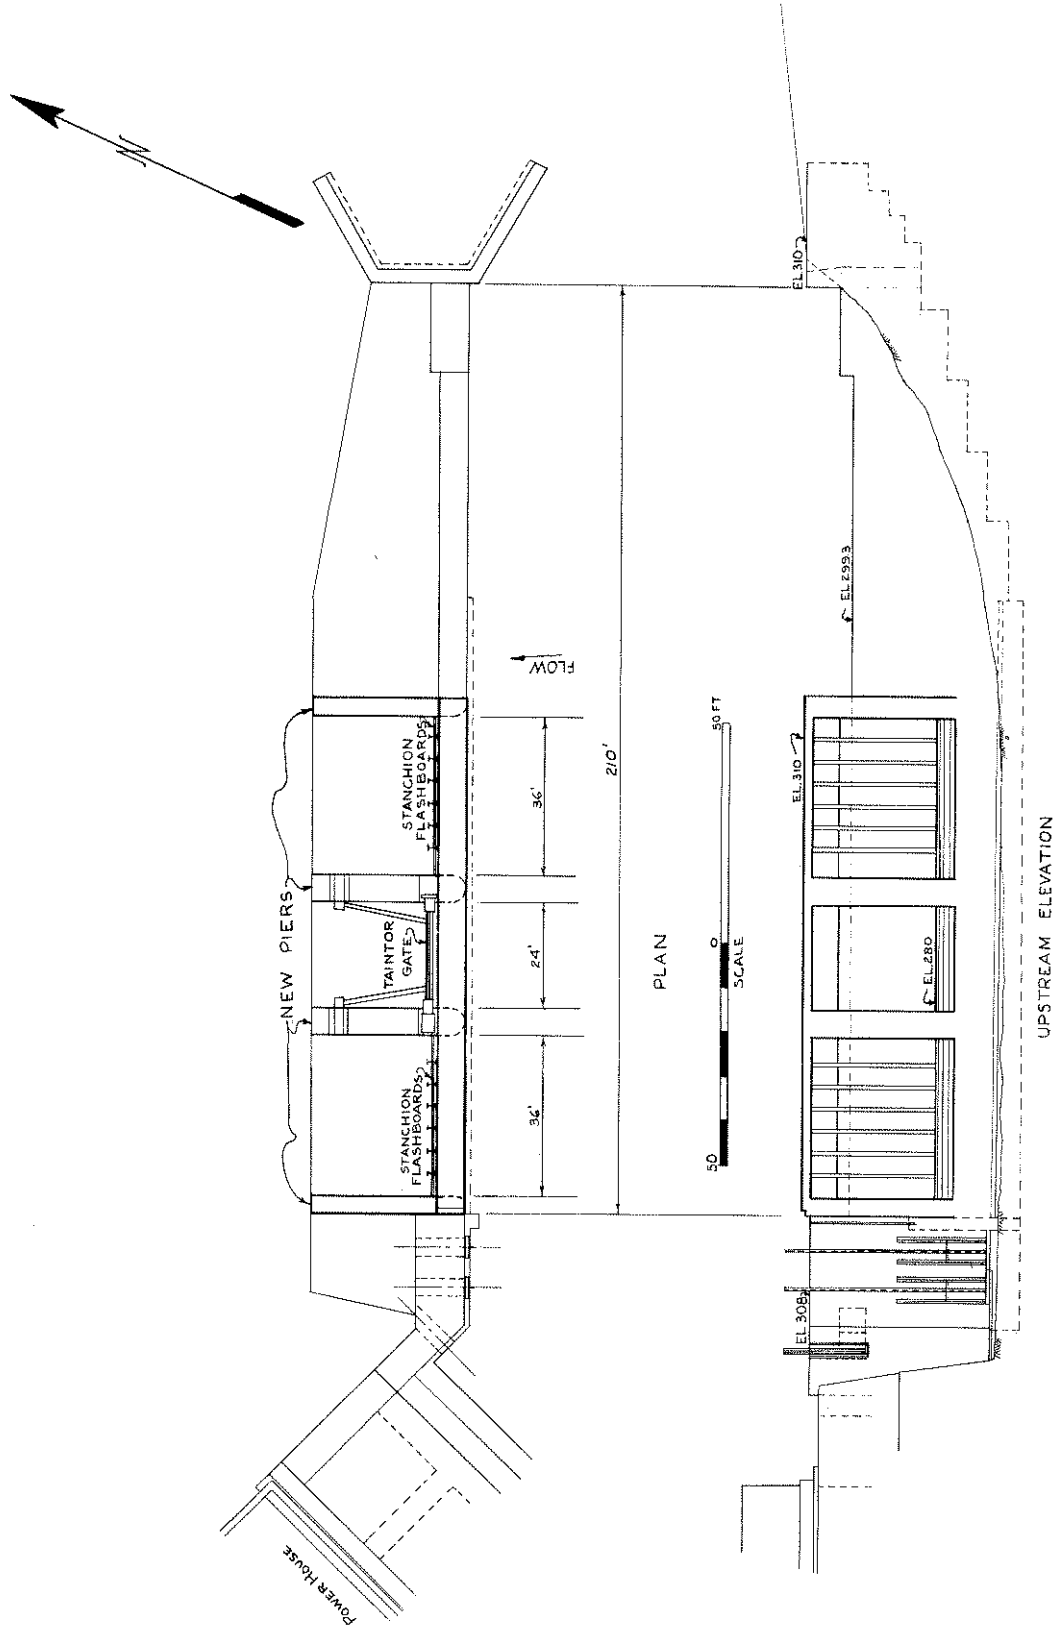
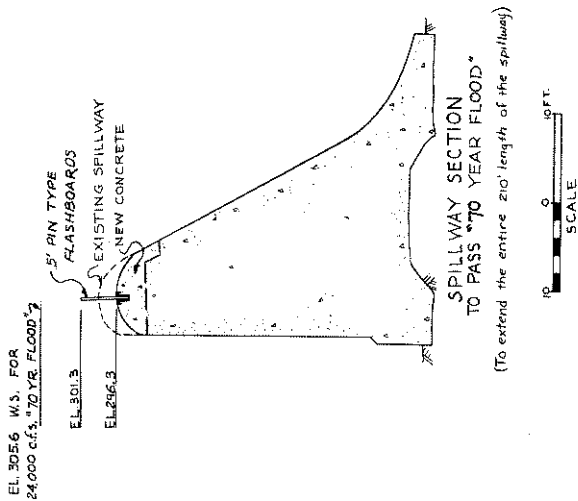
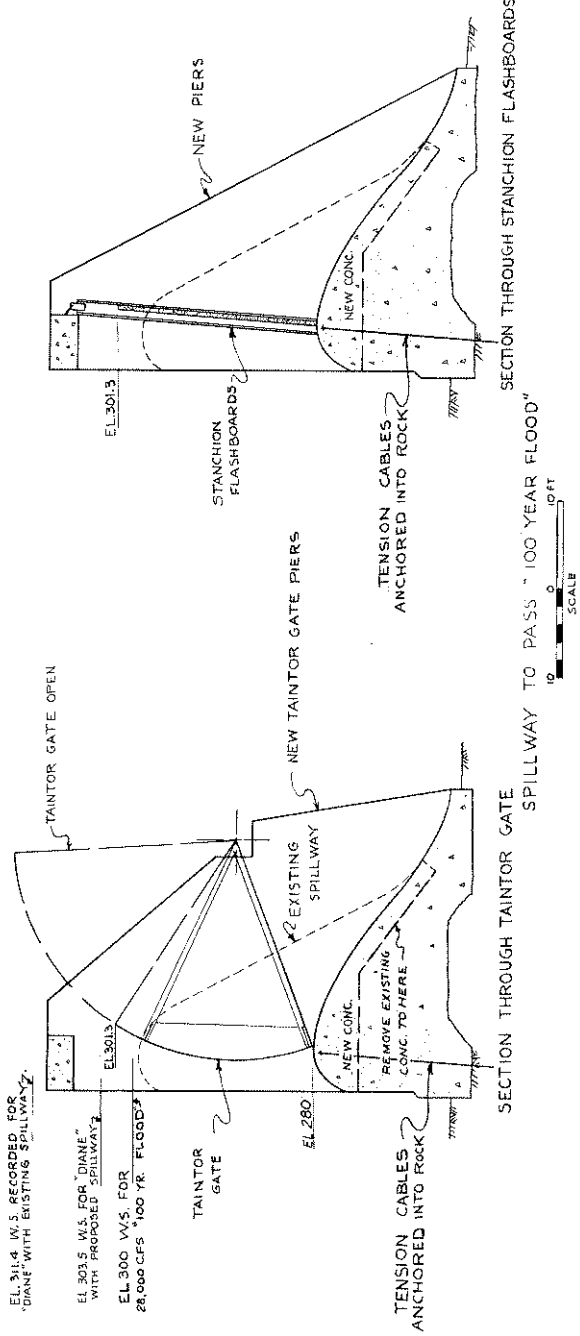
BOARD OF SELECTMEN TOWN OF PALMER, MASS. FLOOD PROTECTION SURVEY				SCALE AS NOTED	CLIENT JOB	DWG. NO.
THREE RIVERS DAM INCREASED SPILLWAY CAPACITY PLAN, ELEVATION AND SECTIONS				CHAS. T. MAIN, INC.	BOSTON MASSACHUSETTS	2089 1 R2
DATE	ISSUED FOR	DRAWN	REVISIONS	CHECKED	DATE	
DATE MADE SEPT. 14, 1956		IN CHARGE W.T.H.

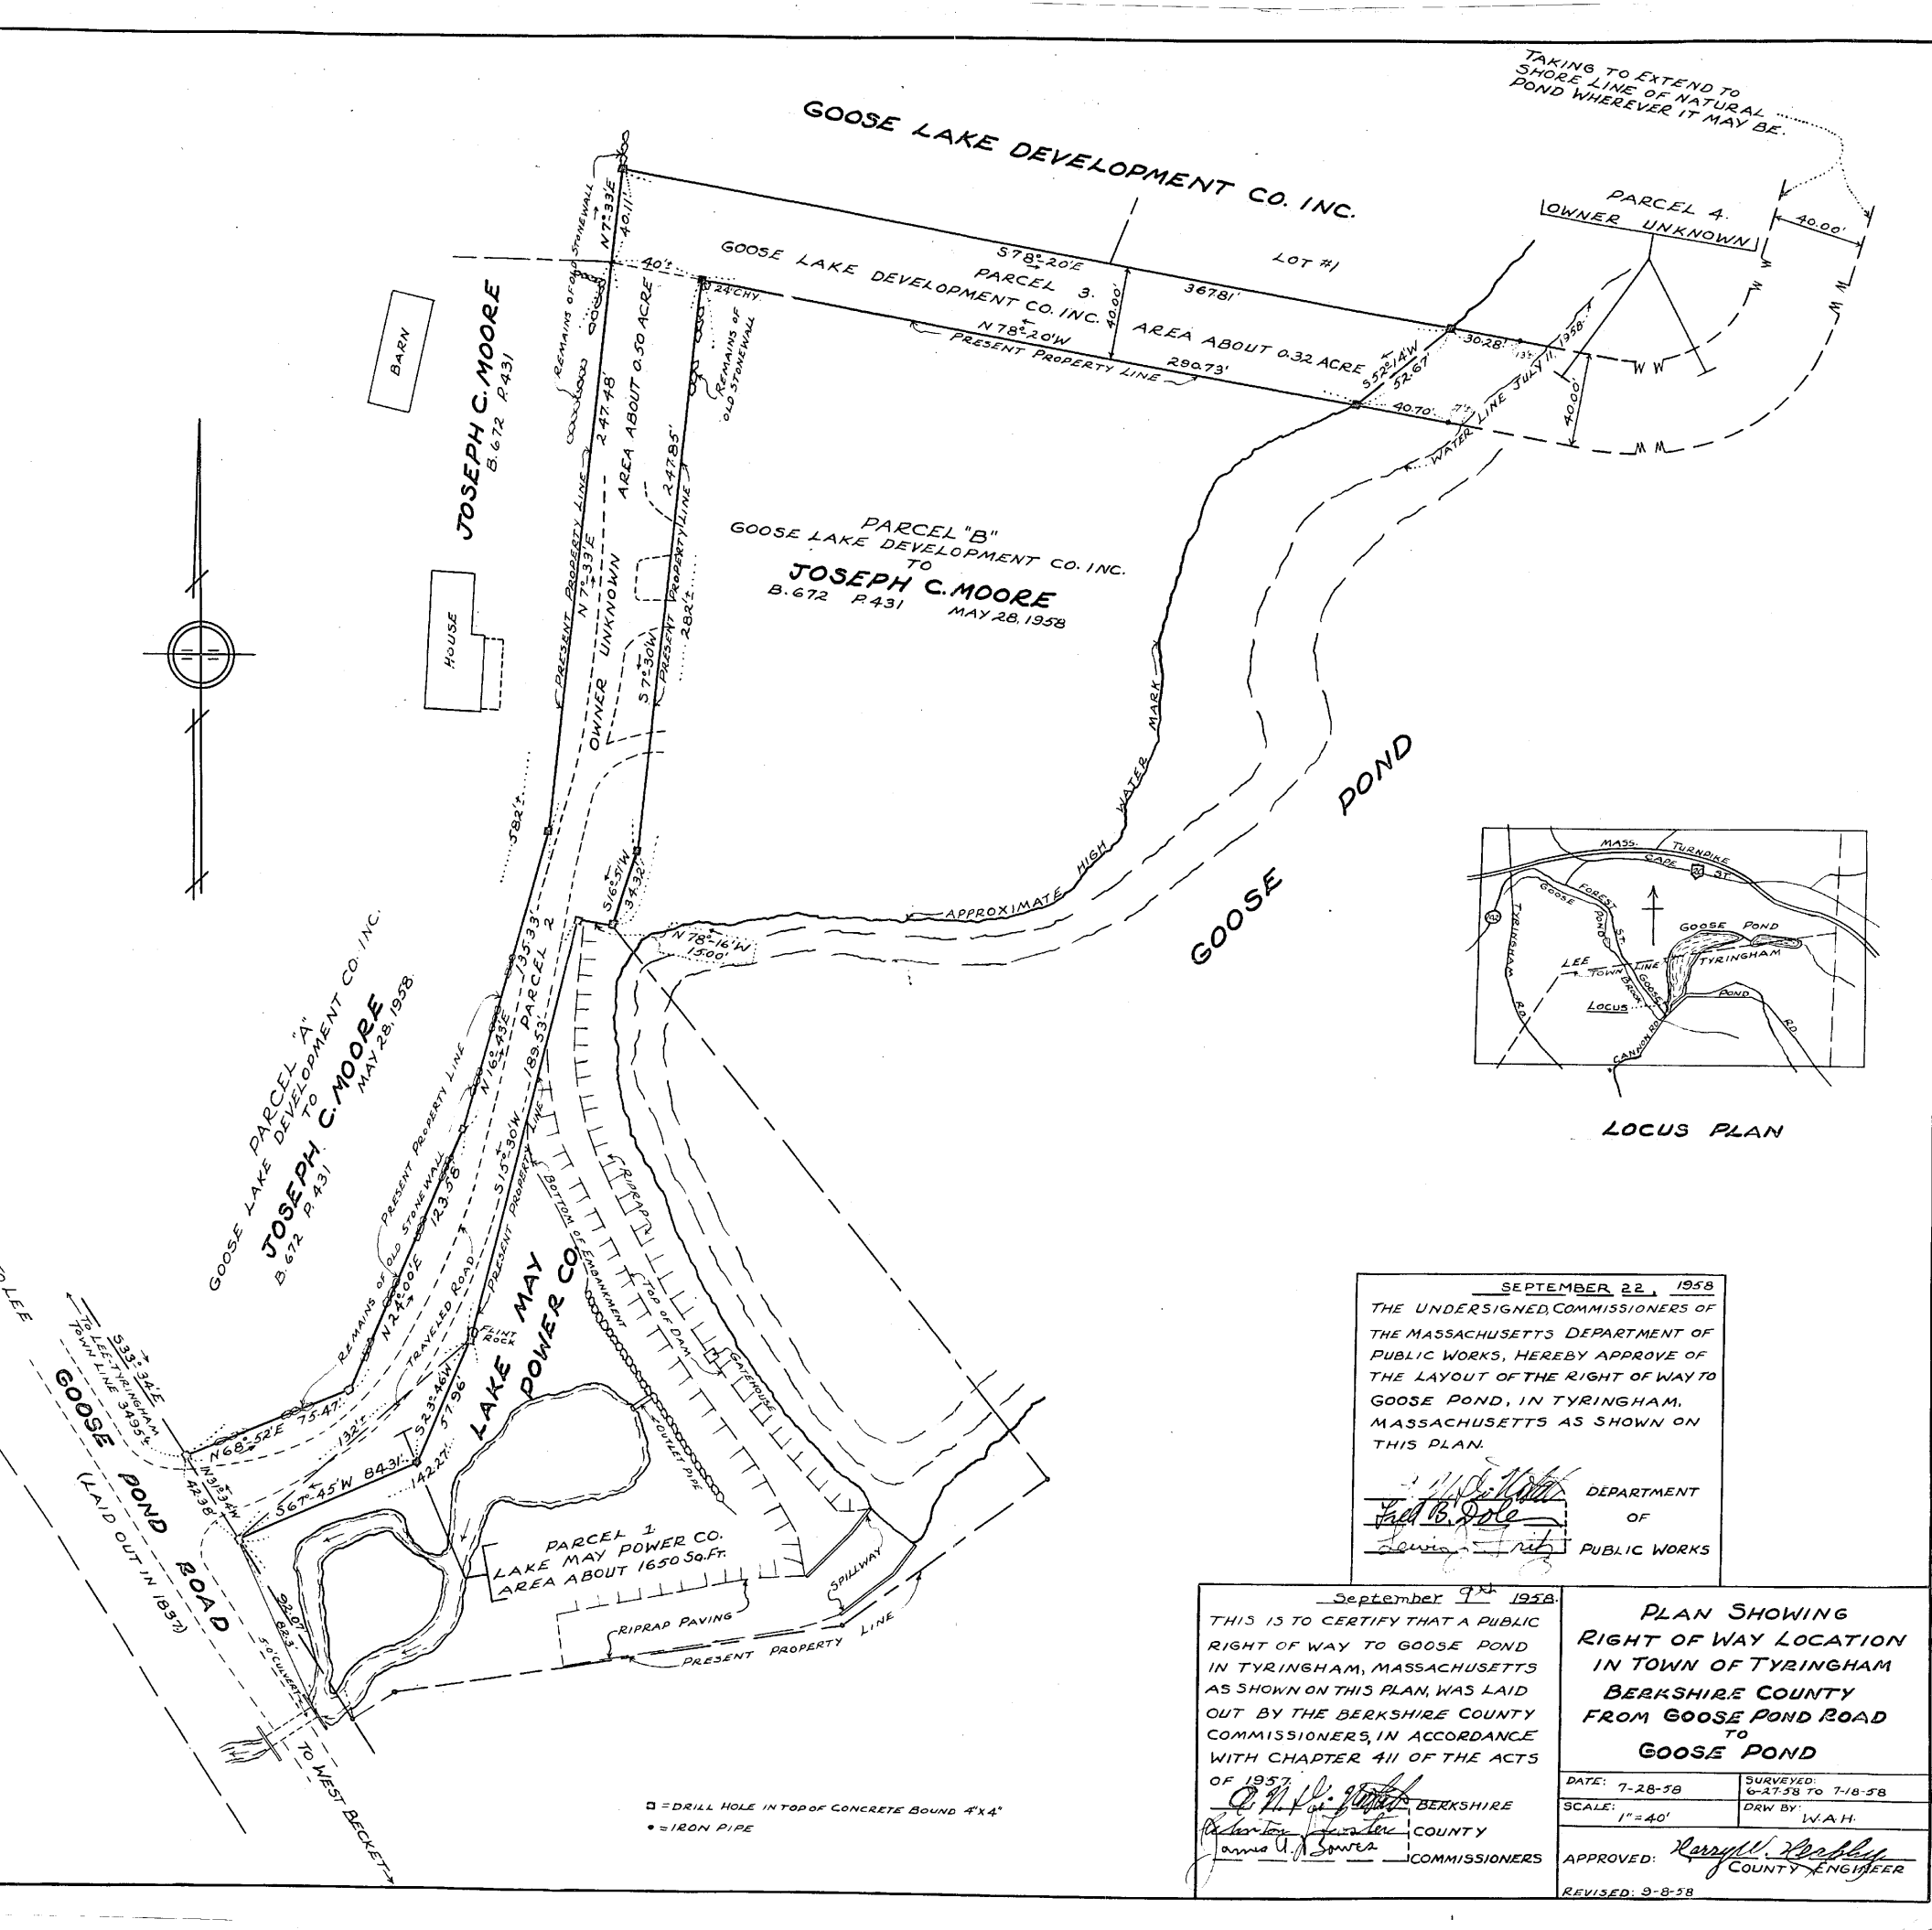
LOCUS PLAN

DATE: 7-28-58 SURVEYED: 6-27-58 TO 7-18-58  
SCALE: 1" = 40' DRW BY: W.A.H.

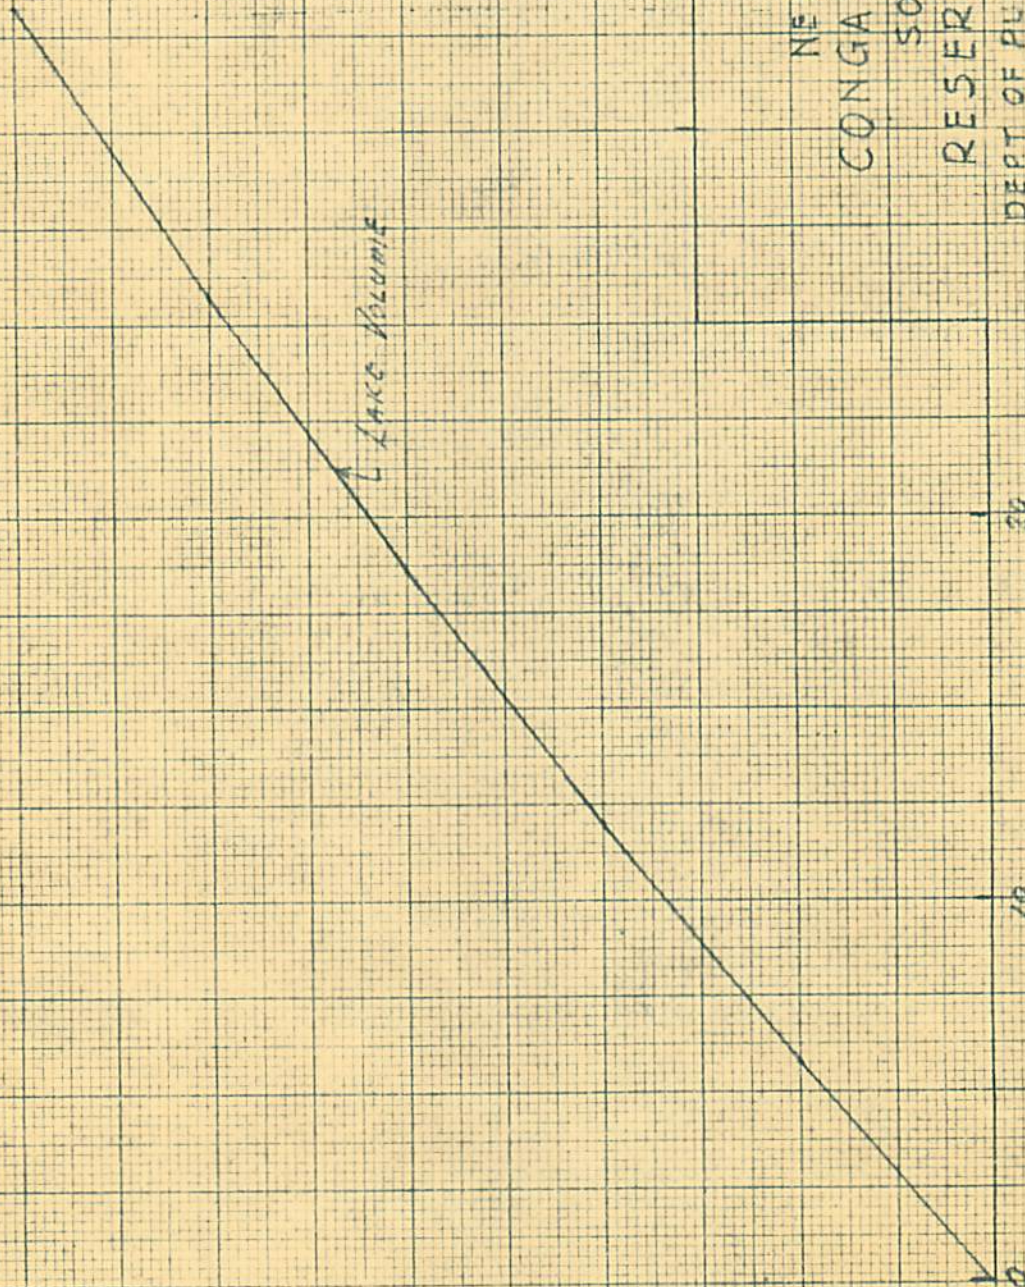
PLATE II

LAKE VOLUME

NEW OUTLET  
CONGAMOND LAKES  
SOUTHWICK

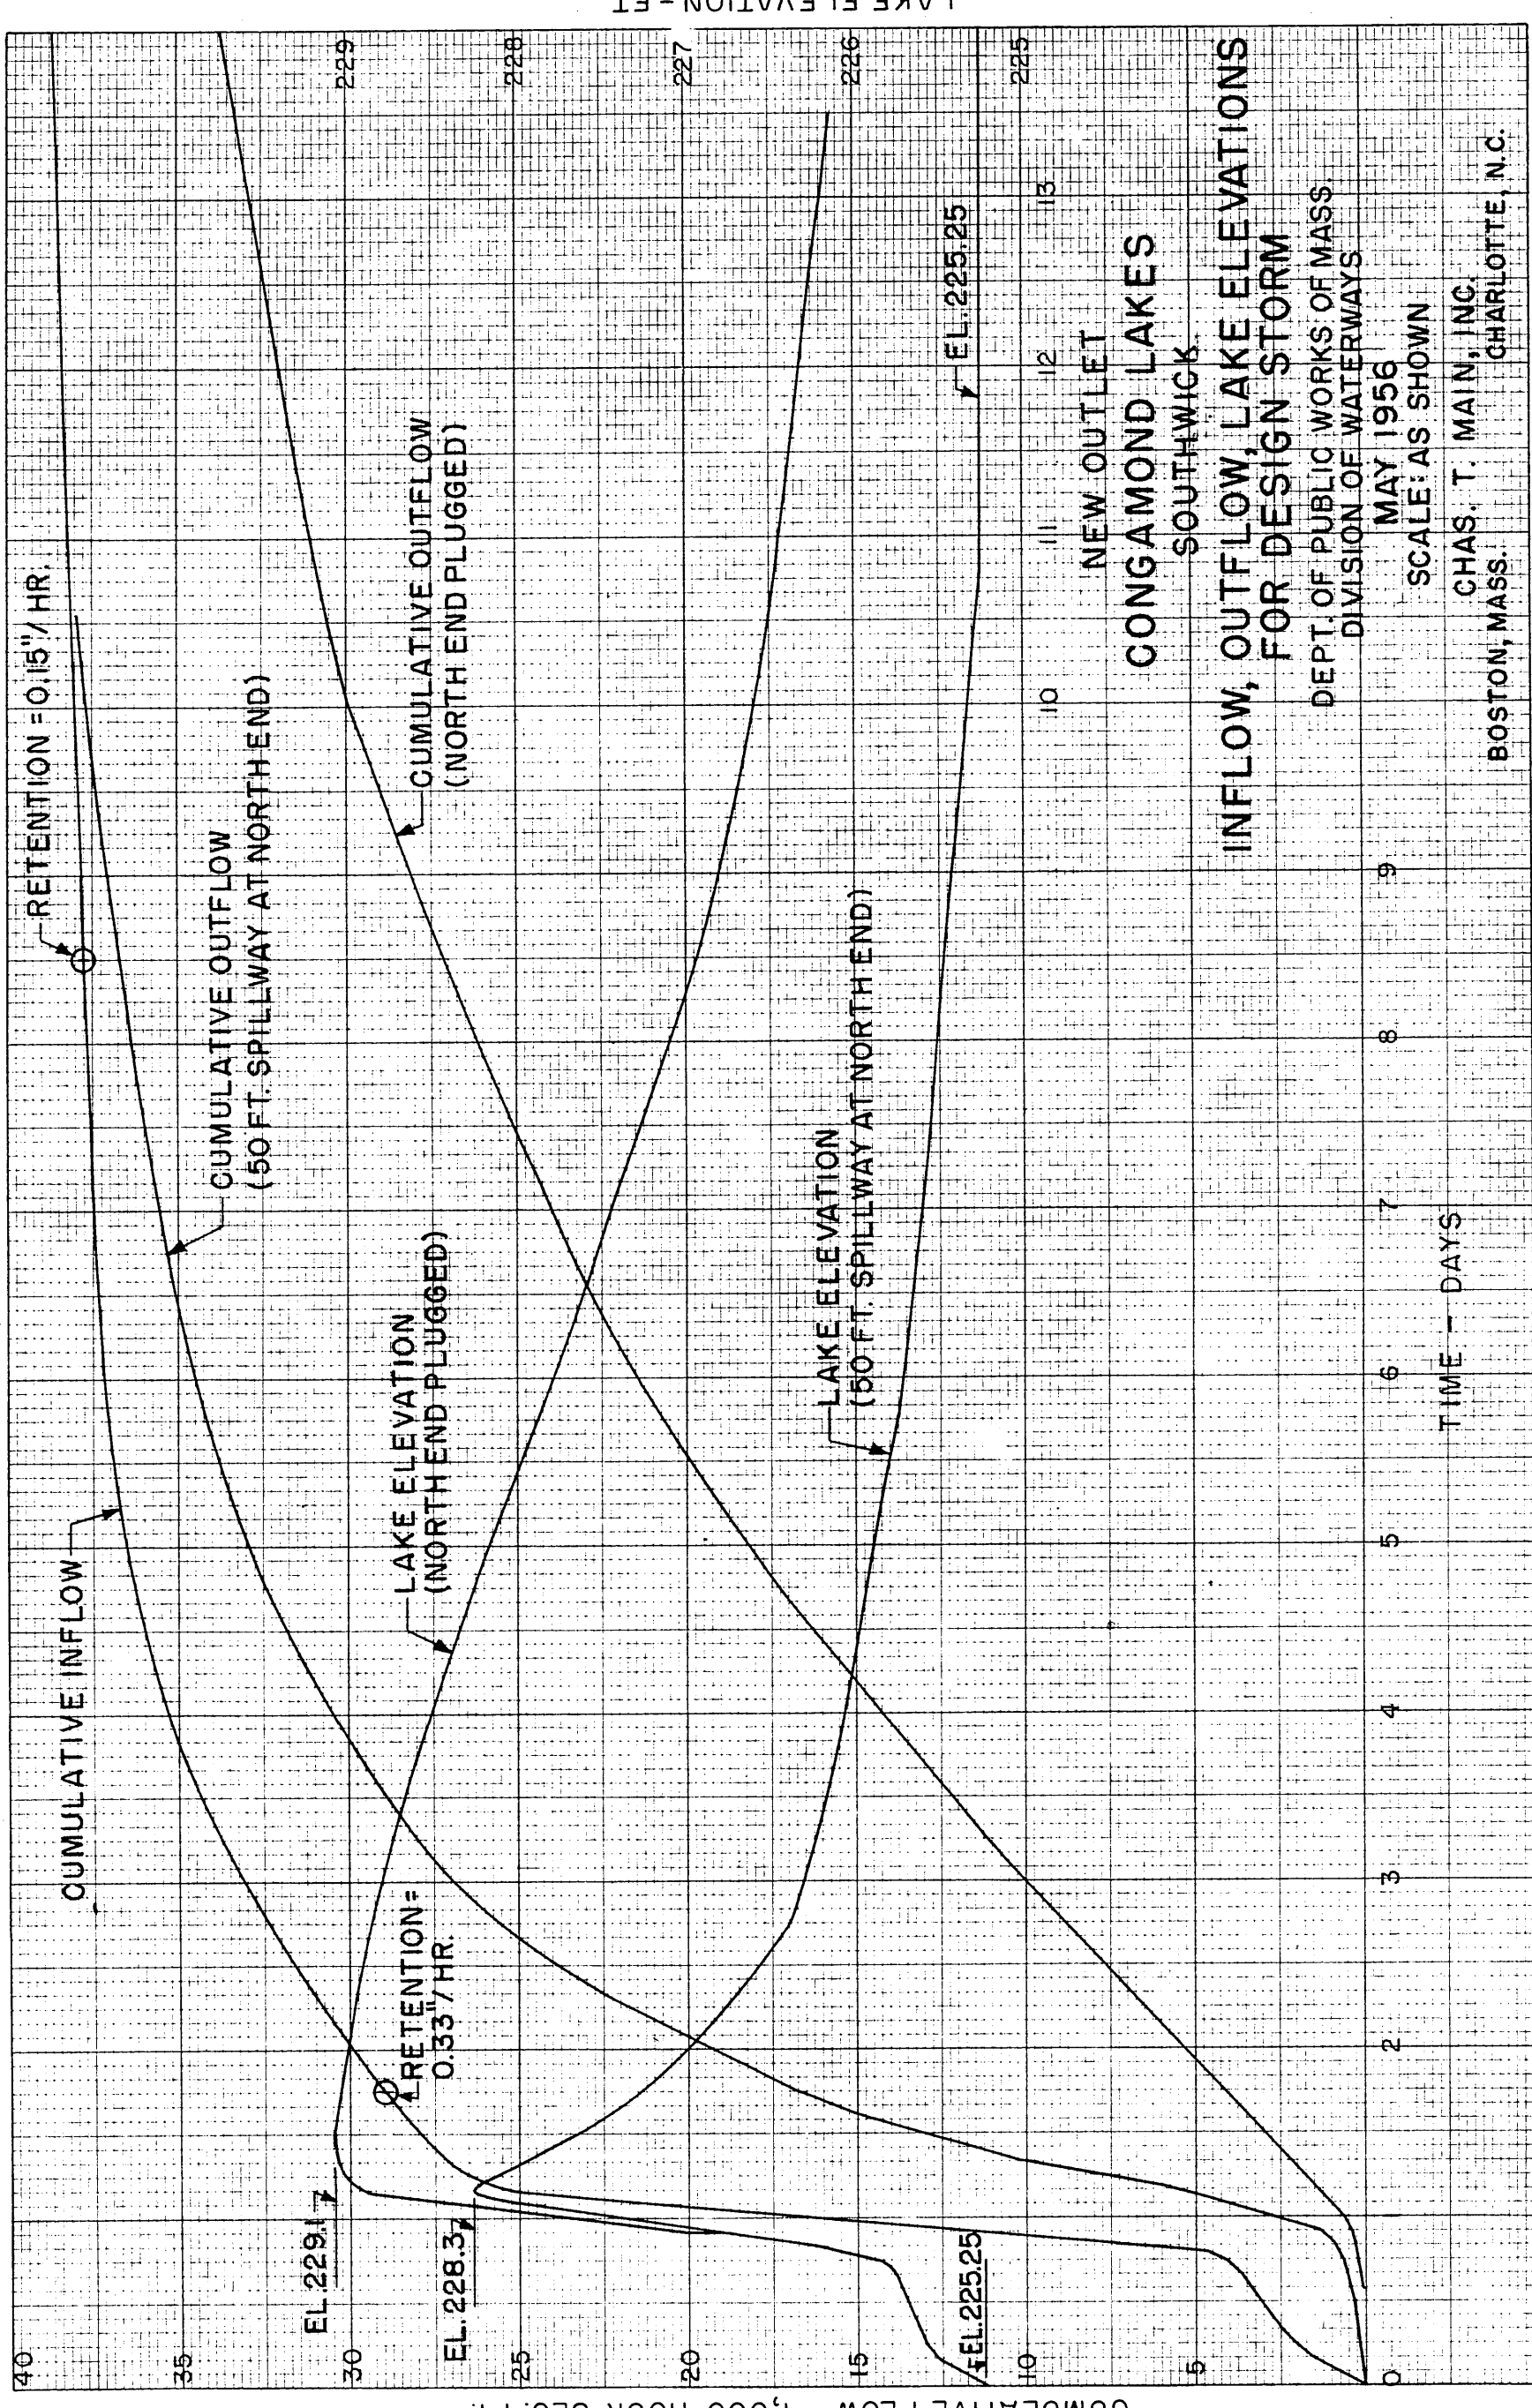
PLATE V

LAKE ELEVATION - FT.

CUMULATIVE FLOW - 1,000 HOUR SEC. FT.

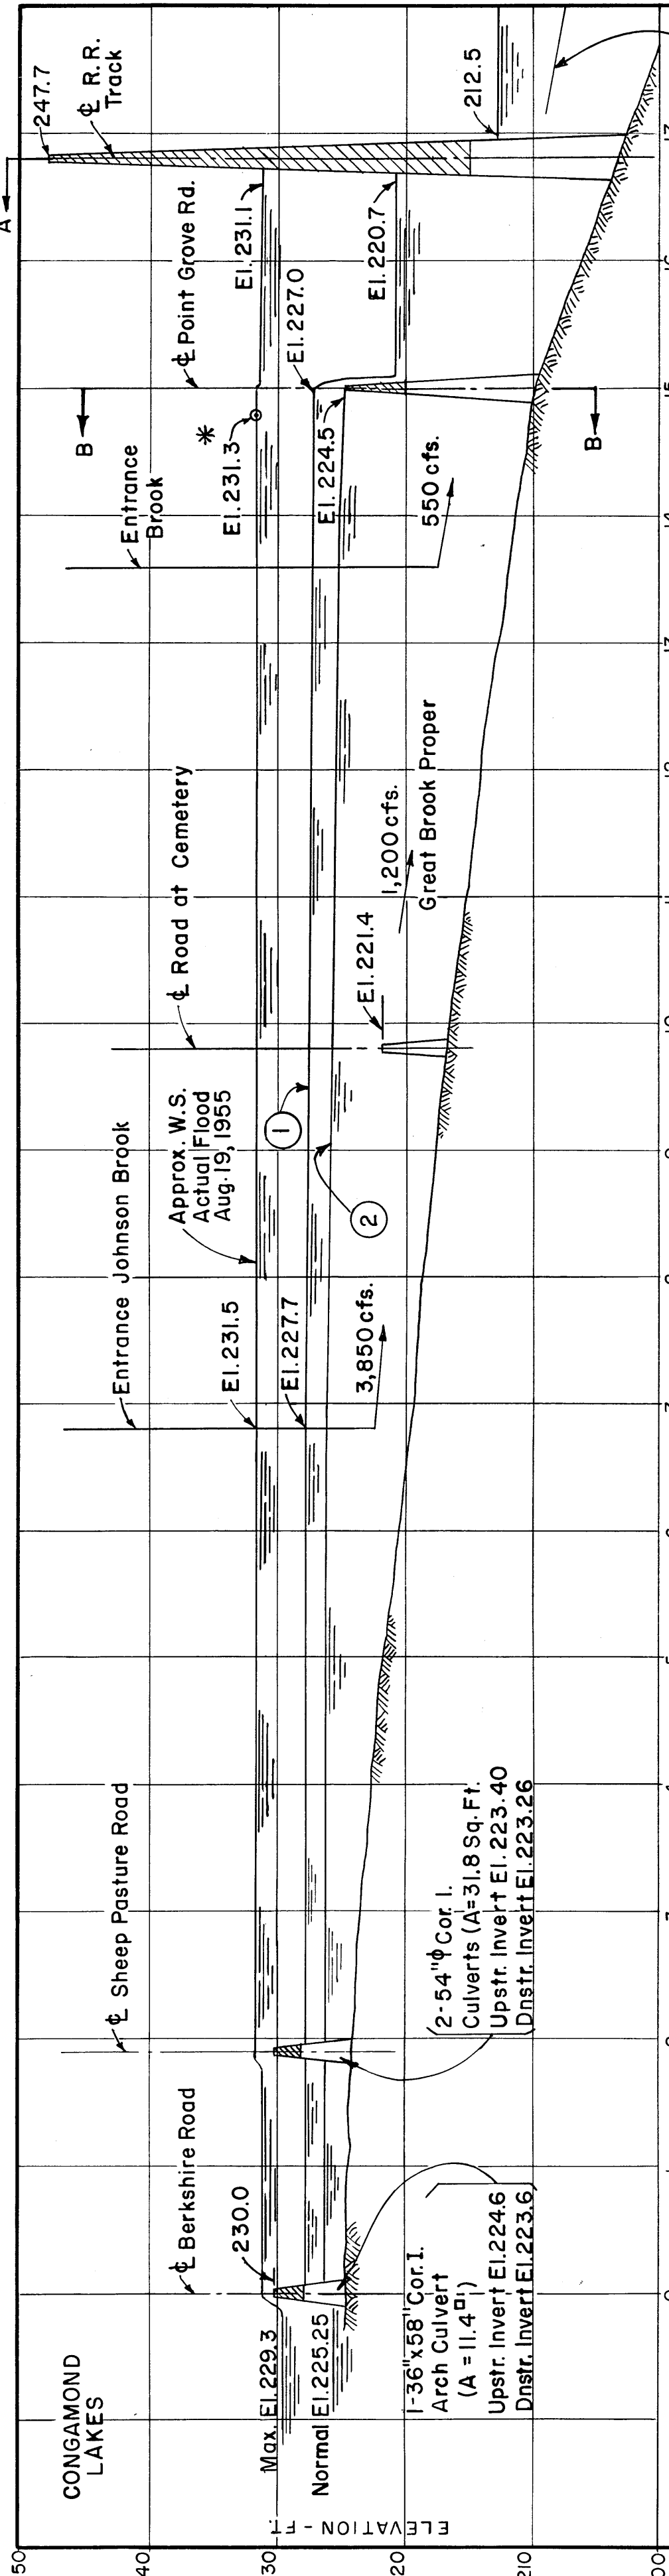
① Approx. W.S. with Added Culvert at R.R.

② Approx. W.S. with Added Culvert at Point Grove Road

\* Actual El. Measured  
at Convalescent Home.

Q = 3,610 cfs Max (Actual Flood-Aug. 1956)  
Assume Q = 4,000 cfs. for Lowered Levels

NEW OUTLET  
CONGAMOND LAKES  
SOUTHWICK  
PROFILE OF GREAT BROOK  
DEPT. OF PUBLIC WORKS OF MASS.  
DIVISION OF WATERWAYS  
MAY 1956

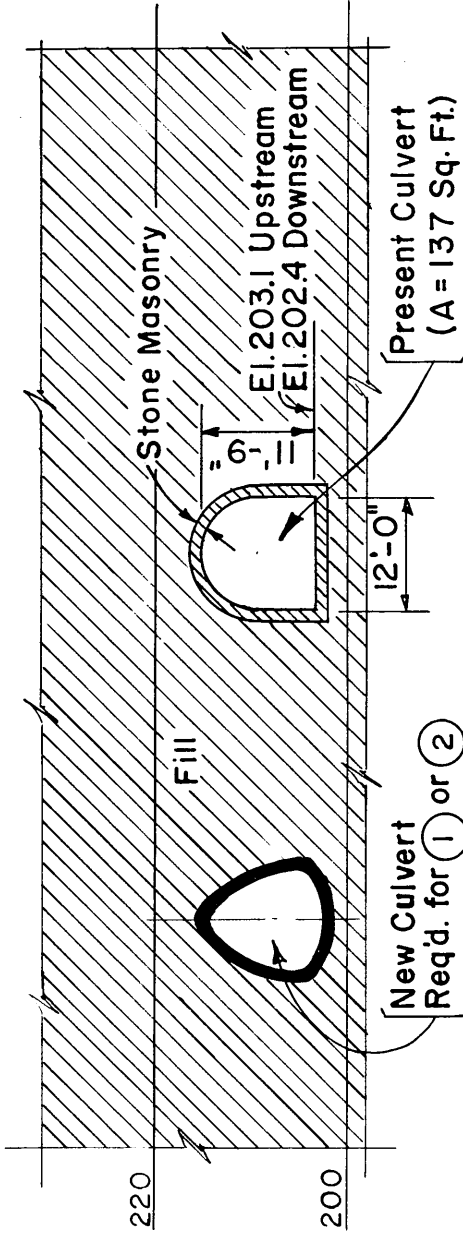
SECTION A-A

Scale: 1" = 20'-0"

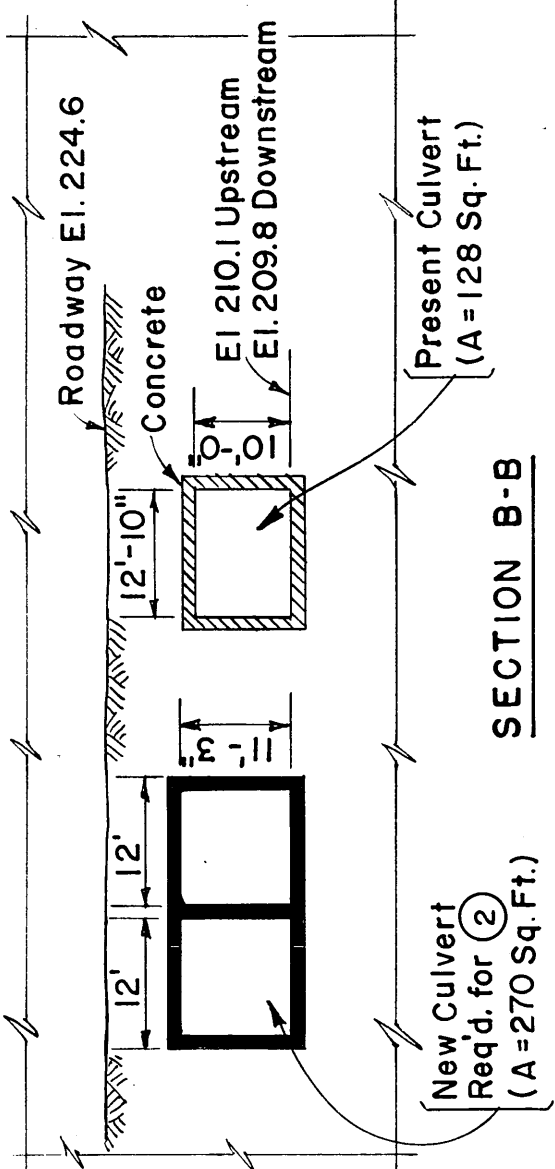
SECTION B-B

Scale: 1" = 20'-0"

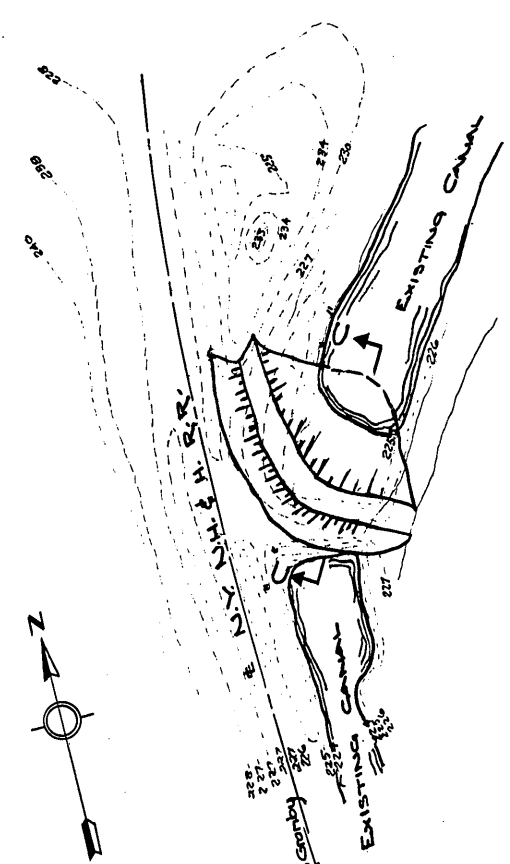
PLAN B  
SCALE: 1"=40'-0"

SECTION C-C'  
SCALE: 1"=20'-0"

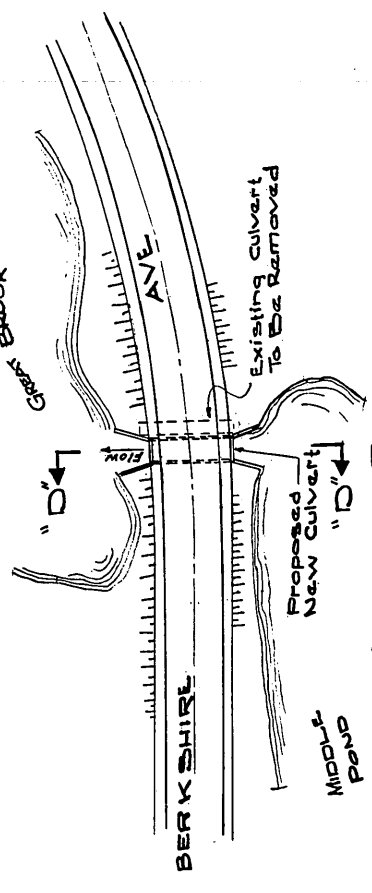
PLAN C  
SCALE: 1"=40'-0"

SECTION D-D'  
SCALE: 1"=20'-0"

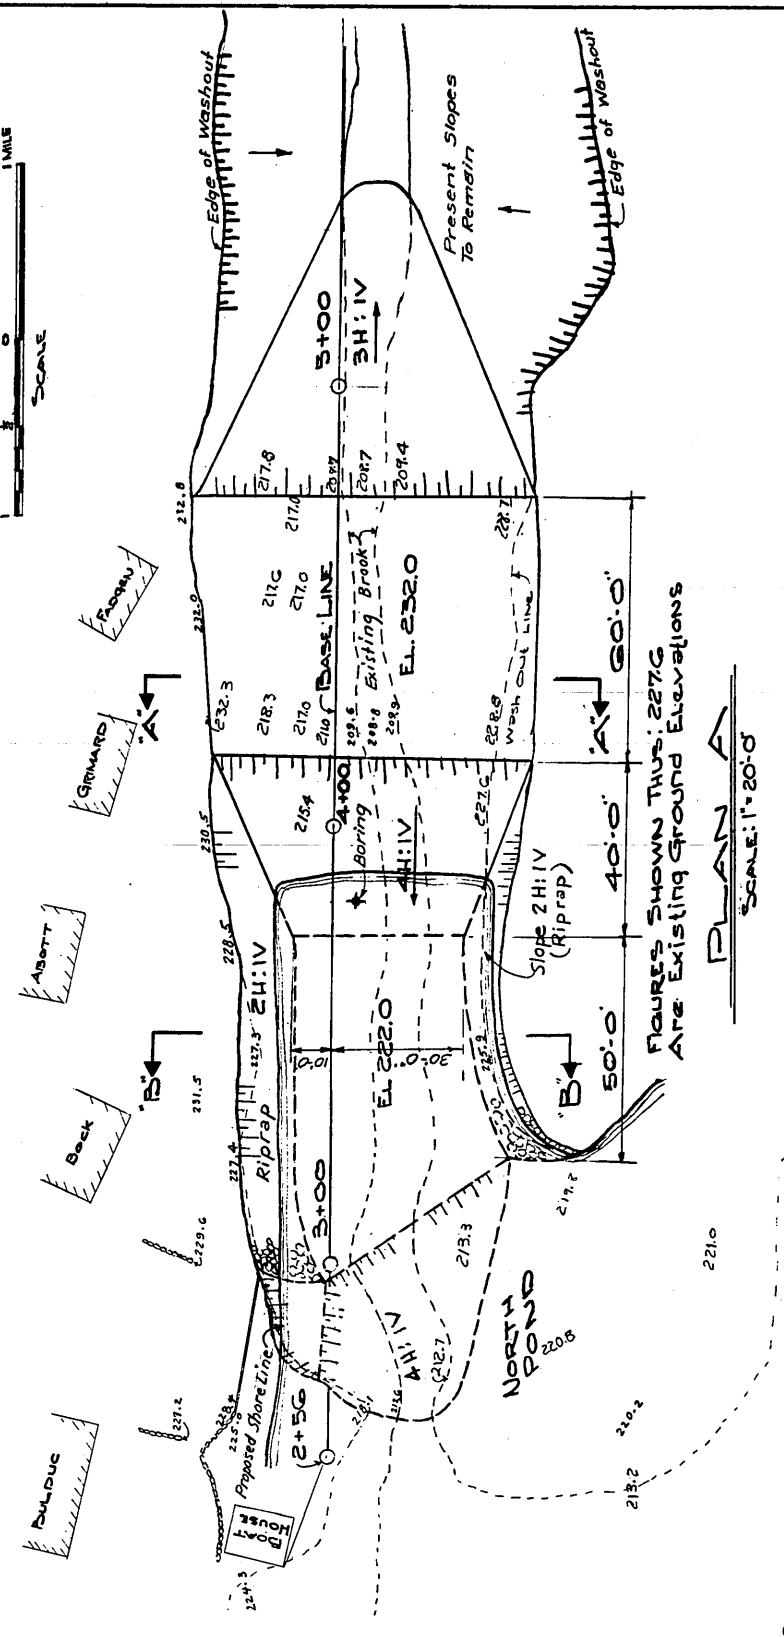
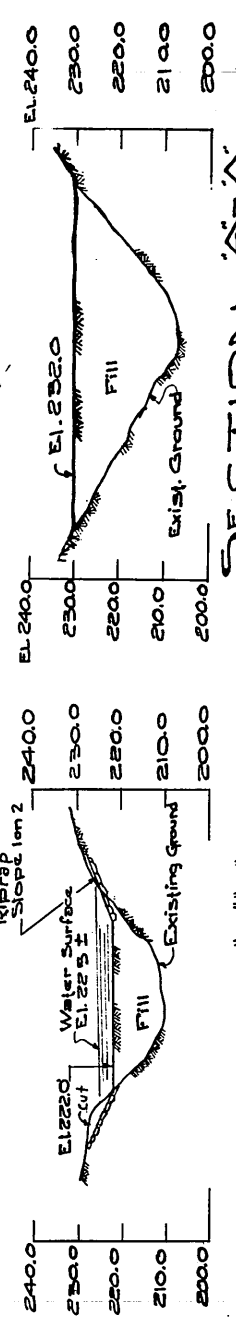
SECTION A-A'  
SCALE: 1"=20'-0"

FIGURES SHOWN THUS: 227C  
ARE EXISTING GROUND ELEVATIONS

NEW OUTLET  
CONGAMOND LAKES  
SOUTHWICK  
ALTERNATIVE NO. 1  
DEPARTMENT OF PUBLIC WORKS OF MASSACHUSETTS  
DIVISION OF WATERWAYS  
MAY 1956  
SCALE: AS SHOWN  
CHAS. T. MAIN, INC.  
BOSTON, MASSACHUSETTS CHARLOTTE, NORTH CAROLINA

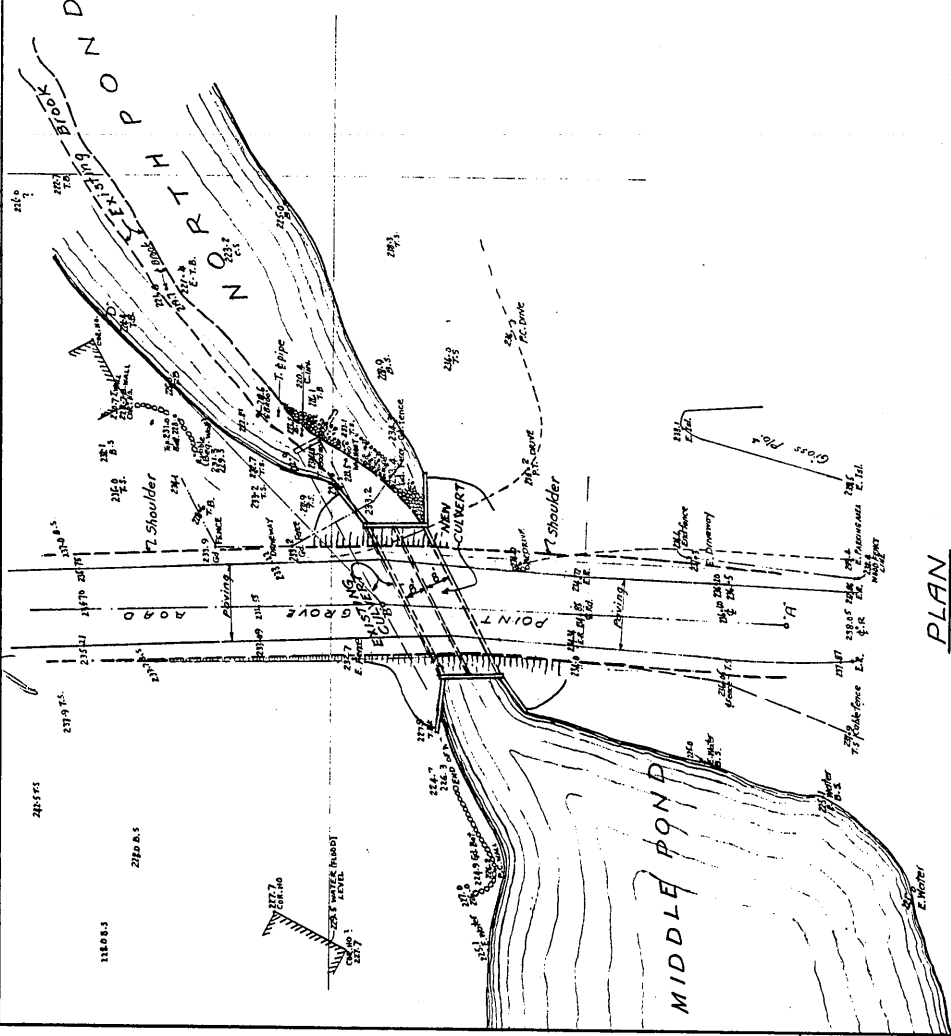
PLAN  
PROPOSED NEW CULVERT  
POINT GROVE ROAD  
Scale: 1"=30'

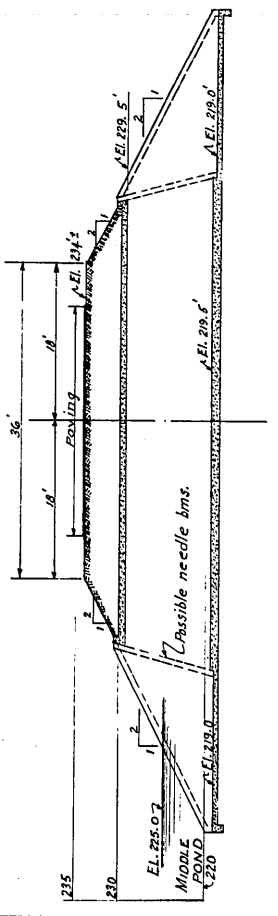
SECTION THROUGH CULVERT  
Scale: 1"=10'

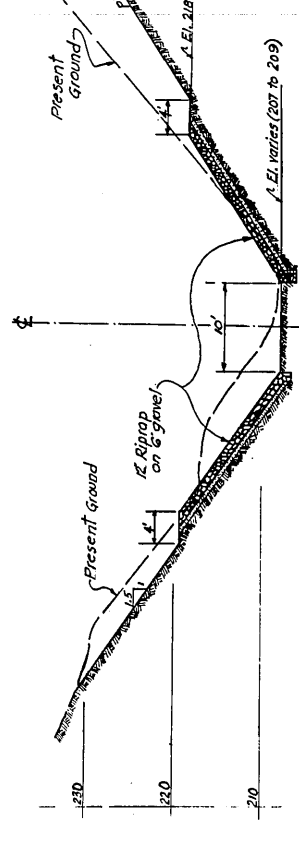
SECTION A-A TYPICAL FOR 10' WIDTH  
(20' WIDTH SIMILAR EXCEPT NO RIPRAP)  
Scale: 1"=10'

NOTE:  
10' Width to Sta. 6+66  
Transition from 10' to 20' to Sta. 9+66  
20' Width for remainder of distance  
Culvert of South Longyard Road to be  
increased from 4ft to 10ft Dia.
